## 9 Tree Barge

### 9.1 History of the Tree Barge

### 9.4 Representative Photographs

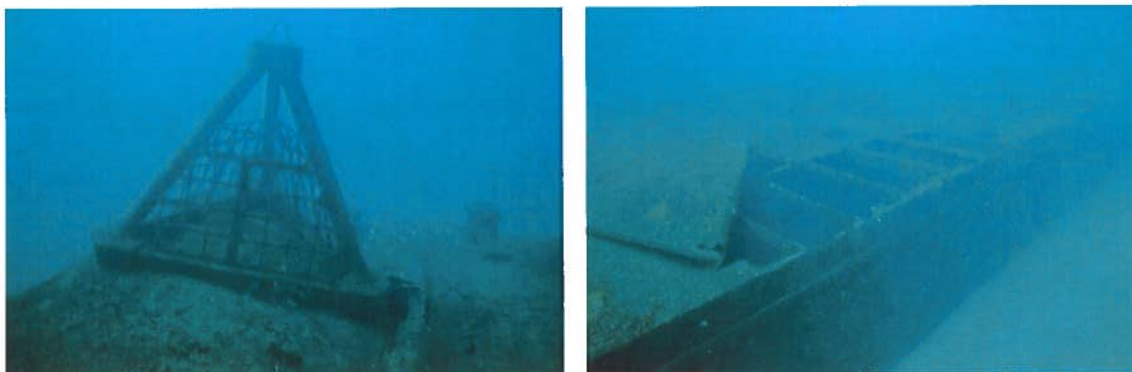
Figure 16. Tree Barge Photographs

The Tree Barge remains on the bottom in an upright position with the deck level; no notable listing. The bow damaged during deployment faces easterly at 80 degrees and the stern faces westerly at 260 degrees. The highest profile is where the damaged bow is buckled, where a depth of 175 feet can be found. In May of 2005 four concrete/steel Florida Special ReefMakers Units were deployed between the Tree Barge and the nearby ship the Wickstrom. The southernmost ReefMaker unit landed on top of and upright at the east end of the Tree Barge. At the apex of that unit a depth of 167 feet is found. Some minimal scouring of the sand /shell bottom has occurred, under and immediately adjacent to the hull/seafloor interface. Water depths in the scoured areas were 190 feet, while surrounding water depths at the bottom were 188 feet. There seems to have been no movement of the barge since original deployment in 2002.

Underwater photographs of the Tree Barge are shown in Figure 16. The ReefMaker unit is shown on top of the Tree Barge in the left photo, and the right photo shows the 2-foot scour along the side of the barge, and the damaged top.

The Tree Barge was considered a derelict abandoned vessel and was in poor condition when acquired by Martin County. Before deployment offshore, some areas of the deck could not be walked on because of thinning deck plates and holes in the steel deck. As a working barge this is not a favorable asset but underwater as an artificial reef the holes provide access for fish and marine life. On the north center section of the deck, a large area of peeled open deck plates was located and photographed, as shown in Figure 16. This damage probably occurred during one of the three major hurricanes that passed through Martin County in 2004 and 2005. This actually could be looked at as a positive thing for the overall artificial reef's productivity, as it allows marine life easier access in and out of the hull.

This reef site had not been monitored since August 2003. The barge survived the 2004 and 2005 hurricanes, but a portion of the deck was peeled back, allowing more access for fish to the interior spaces. The barge has numerous attached benthic species, and the most significant sport and food fish species observed on this reef were Black Grouper, Gray Snapper, Black Seabass, Red Snapper and Greater Amberjack.
