7 Tree Barge

7.1 History of the Tree Barge

7.2 Tree Barge Orientation

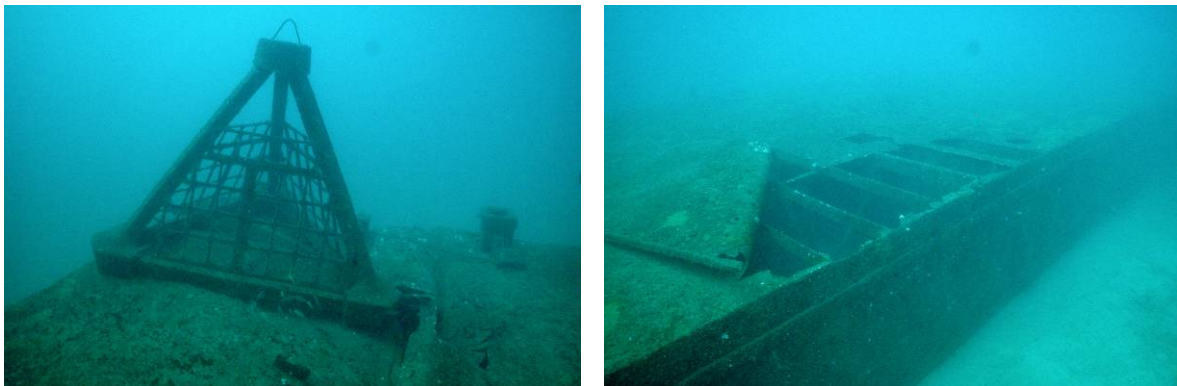
Figure 15. Tree Barge June 3, 2006 Photographs

The Tree Barge remains on the bottom in an upright position with the deck level; no notable listing. The bow damaged during deployment faces easterly at 80 degrees and the stern faces westerly at 260 degrees. The highest profile is where the damaged bow is buckled, where a depth of 175 feet can be found. In May of 2005 four concrete/steel Florida Special ReefMakers Units were deployed between the Tree Barge and the nearby ship the Wickstrom. The southernmost ReefMaker unit landed on top of and upright at the east end of the Tree Barge. At the apex of that unit a depth of 167 feet was recorded. Some minimal scouring of the sand /shell bottom has occurred, under and immediately adjacent to the hull/seafloor interface. Water depths in the scoured areas were 190 feet, while surrounding water depths at the bottom were 188 feet. There is no apparent movement of the barge since original deployment in 2002. Underwater photographs of the Tree Barge are shown in Figure 15. The ReefMaker unit is shown on top of the Tree Barge in the left photo, and the right photo shows the 2-foot scour along the side of the barge, and the damaged top.
